CIA IMA	GERY ANALYSIS DIVISI	ON	
NAME Ban Ken Hwy. Bridge over Nam Mat Bridge No. 1L on NE 48-2	Country Laos	19 35N - 103 40E PE 599664	 25X´
MAP JOG (A) 1501 NE 48-2		BRIEF NO: PIB 75200 October 1966	25X ²

CIA IMAGERY ANALYSIS DIVISION		
NAME	COUNTRY	COORDINATES
Ban Dong Hwy. Bridge		19 39N - 103 18E
Bridge No. 1L on NE 48-1	Laos	UG 224560
		BRIEF NO:
		PIB 75201
MAP JOG (A) 1501 NE 48-1		PIB 75201 October 1966

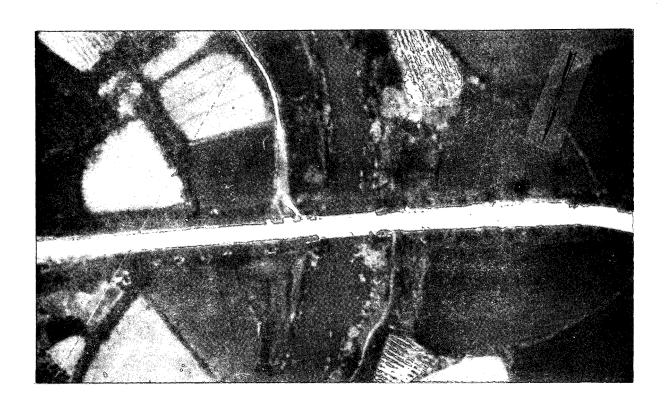
CIA IMAGER	RY ANALYSIS DIVISION		
25X1	NAME Xom Xoi Hwy. Bridge NW over stream Bridge No. 13 on NE 48-11	COUNTRY North Vietnam	17 37N - 106 29E XE 570485	
25X1	MAP JOG (A) 1501 NE 48-11		BRIEF NO: PIB 75204 October 1966	
	LOCATION: At Xom Xoi on Route 101. DESCRIPTION:			
25X1	LENGTH WIDTH TYPE Deck	MATERIAL WOOD NO. OF SPANS 2 LENGTH OF EACH SPAN		25X1
	status: Pre-strike			
	COMPENSATIVE ACTION: None			
25X1

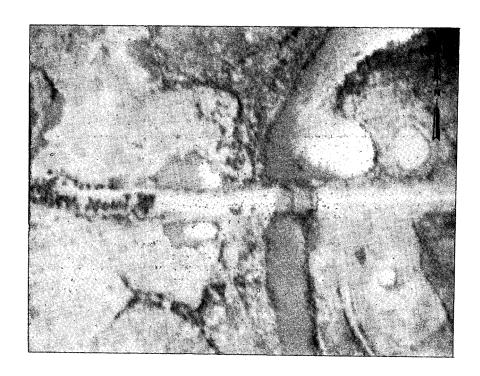
CIA IMAG	ERY ANALYSIS DIVISION		
25X1	NAME Xom Xoi Hwy. Bridge NW over stream	COUNTRY	COORDINATES 17 37N - 106 29E	
	Bridge No. 13 on NE 48-11	North Vietnam	XE 570485	
25X1			BRIEF NO: PIB 75205	
	LOCATION: At Xom Xoi on Route 101.		October 1966	
	DESCRIPTION:			
25X1	LENGTH WIDTH TYPE Deck	material Wood no. of spans 2 length of each span		25X
	Status: Severe deck damage.			
	COMPENSATIVE ACTION:			
	None			
25X1

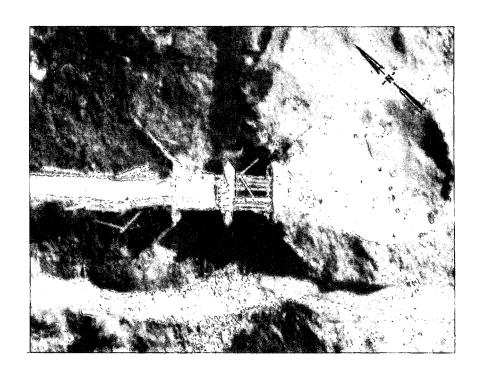
Deck severely damaged.

By-pass causeway.

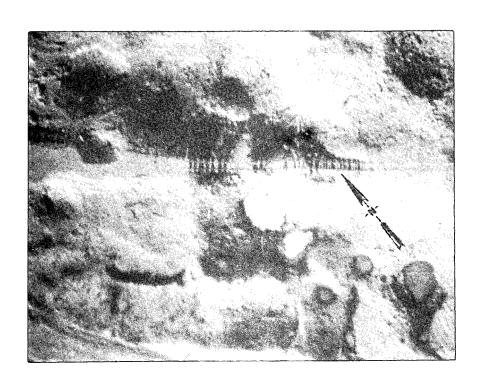
Span heavily damaged; bridge is unserviceable.

None

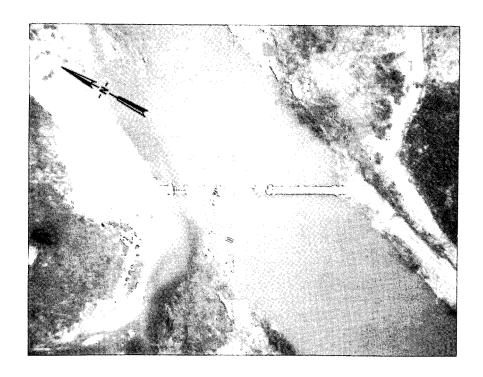
5 spans destroyed; 1 span lightly damaged; 1 span severely damaged; 2 piers destroyed; 3 piers moderately damaged.

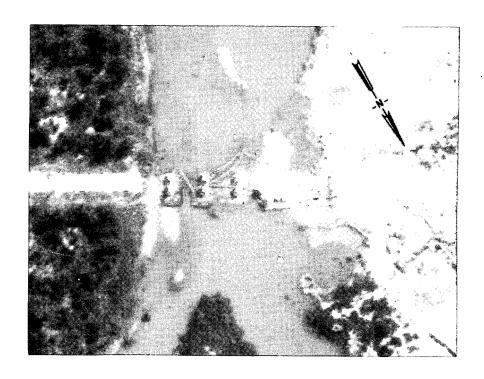
AGERY ANALYSIS DIVISION	
NAME Hoan Iao Hwy. Bridge W ov	rer COUNTRY	COORDINATES
stream Bridge No. 25 on NE 48-12	North Vietnam	17 35N - 106 31E XE 620455
MAP JOG (A) 1501 NE 48-1	2	BRIEF NO: PIB 75248 October 1966
LOCATION: 0.8 nm NW of Hoan Lao		1 000001 1,000
LENGTH WIDTH TYPE Deck	MATERIAL Wood and (NO. OF SPANS 6 LENGTH OF EACH SPAN	concrete
status: 2 piers destroyed; all sp	ans destroyed; abutments	intact.
COMPENSATIVE ACTION:		
By-pass causeway.

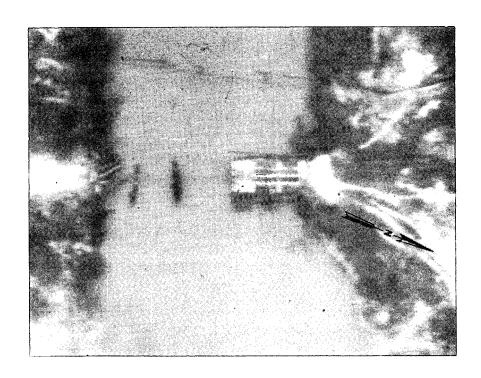
CIA	IMAGERY ANALYSIS DIVISION	
•	NAME	COUNTRY	COORDINATES
	Hoa Loc Hwy. Bridge Bridge No. 57 on NE 48-12	North Vietnam	17 05N - 106 58E YD 101891
25X1			BRIEF NO: PIB 75249
	MAP JOG (A) 1501 NE 48	-12	October 1966
	DESCRIPTION:	Lap on unnumbered route.	
25X1	LENGTH	material Wood and c	concrete
	TYPE Deck	NO. OF SPANS 5	25X1
	status: Three spans destroyed; 2	spans damaged; abutments i	ntact.

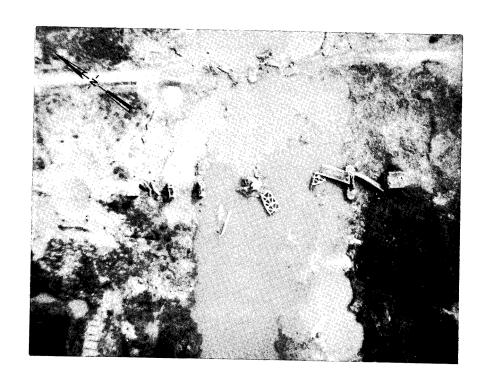
CIA IMAGERY ANALYSIS DIVISION			
,	N AME	COUNTRY	COORDINATES	
	Xom Phuong RR. Bridge Bridge No. 4 on NE 48-12	North Vietnam	17 32N - 106 33E XE 643405	
25X1			BRIEF NO: PIB 75254	
	MAP JOG (A) 1501 NE 48-12		October 1966	
	LOCATION: 0.3 nm S of Xom Phuong on a	abandoned Vinh/Dong Hoi	RR.	
	DESCRIPTION:			
25X1	width 350' approx. width Language Deck	material Concrete no. of spans 7 LENGTH OF EACH SPAN 50	'approx.	
	status: 7 spans destroyed; 3 piers des	stroyed.		
	COMPENSATIVE ACTION:			
	None			
25X1

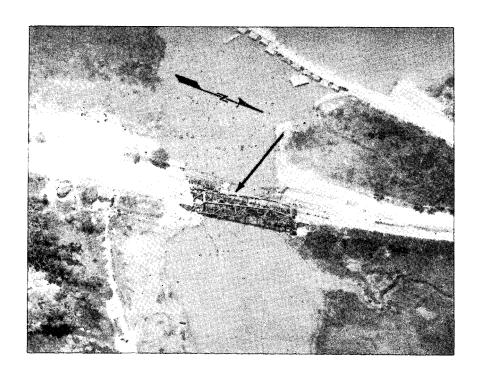
Span dropped and twisted; one abutment heavily damaged.

Serviceable deck-type replacement bridge has been constructed adjacent to the destroyed bridge.

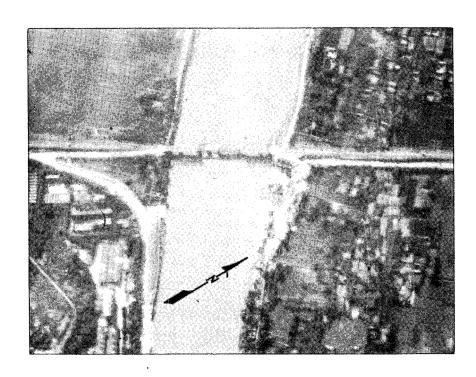
Piers repaired; previously damaged spans replaced by deck-type spans; bridge serviceable to rail traffic; probably not serviceable to vehicular traffic.
COMPENSATIVE ACTION:

By-pass bridge under construction west of bridge; serviceable pontoon by-pass bridge east of bridge. Ferry slips observed but no ferry.

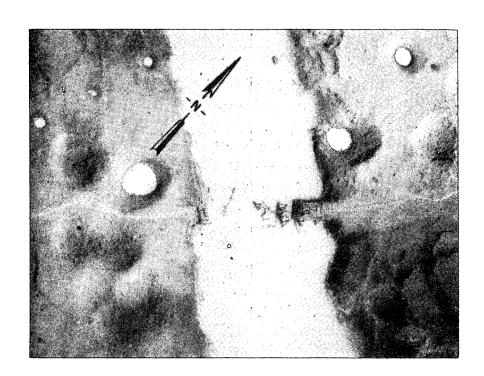
status:
6 spans destroyed; 2 spans heavily damaged; 5 piers heavily damaged; l abutment damaged.

Ford
